Shifting the Canning Bus Bridge Sideways

Ros MacKinlay – Design Engineer, Wyche Consulting

The Perth – Mandurah railway proposed in 2002 required the replacement of an existing Kwinana Freeway bus bridge. As a cost saving alternative the successful tenderer proposed that the existing bridge superstructure be moved rather than rebuilt. In 2005 this curved prestressed concrete bridge superstructure was successfully moved a distance of 9.5 metres South West of its original location to remain in use carrying buses from Canning Highway onto the north bound Kwinana Freeway. This paper provides an example of the economy which is achievable by modifying and re-using an existing structure, but also shows that the bridge engineering challenges for keeping old structures are often more difficult than designing new ones.

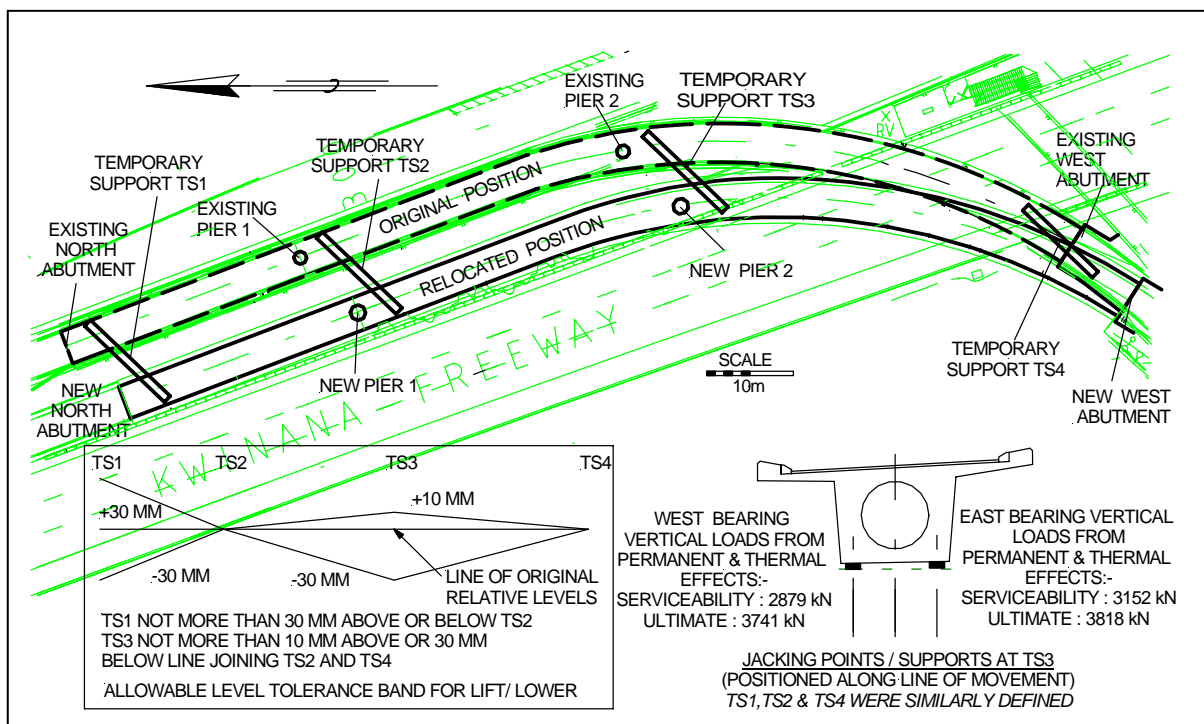
Figure 3: Loads and Tolerances for Vertical Lift of Superstructure

After exhaustive calculations, the vertical and horizontal movement tolerance bands and maximum loads at each temporary support were established for the 3 stages of the relocation. Some of the Stage 1 vertical lift tolerances and loads are shown in Figure 3.

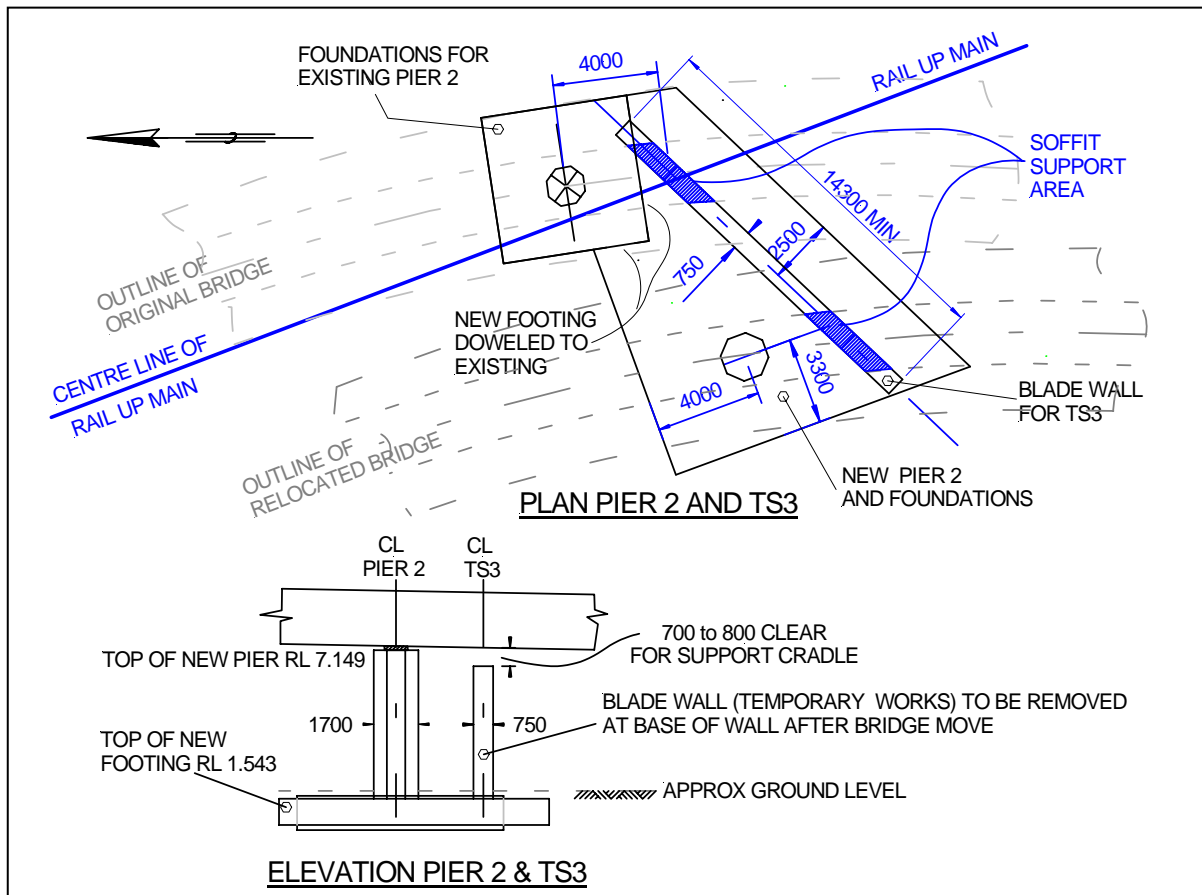
Figure 5: Bridge #1295 Pier 2 Footing

The new piers and footings were required to be designed to resist train impact loads of 3000kN along the rail line and 1500kN perpendicular to the rail. This was facilitated by integrating the existing pier foundations with the new footing and making the footing shape such that the temporary works blade wall was located on the permanent footing. This design ensured that the soil bearing pressures remained within acceptable limits under all load conditions and that there was minimal differential settlement between the old support, the temporary support and the new pier by the time the final bearing changeover was made. See Figure 5.

The temporary works consisted of concrete blade walls near each permanent support. The blade wall foundations were made integral with the foundations for the new and old permanent structures at Pier 1, Pier 2 (see Figure 5) and at the West abutment the temporary blade wall was integrated with the existing abutment foundations. In this way differential settlement between the old foundations, temporary works and new foundations was minimised. Only the lightly loaded TS1 at the North Abutment was totally separate from the permanent works.

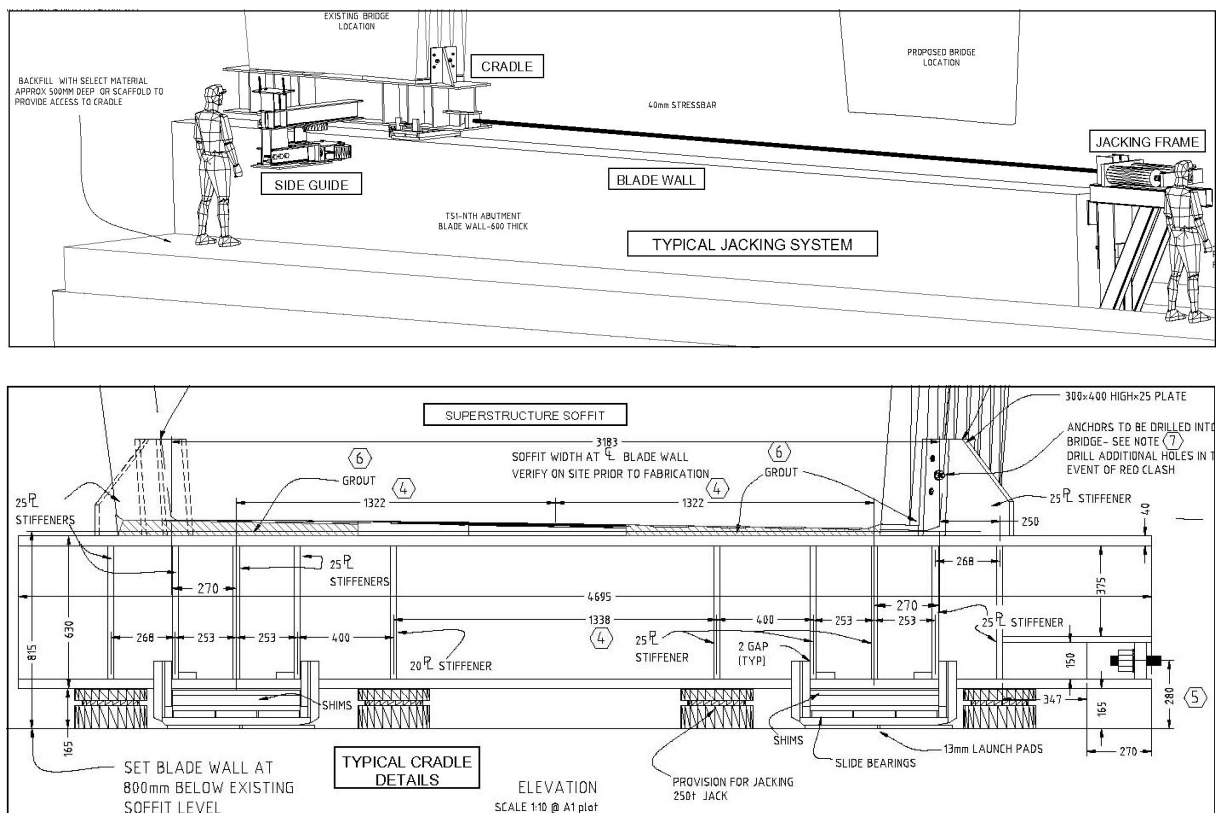
Figure 6: Bridge #1295 Temporary Works Diagram
(Reproduced from Hawkins Engineering Drawings)

A steel cradle was bolted to the sides of the superstructure and grouted to the soffit at each of the temporary support points. Each cradle was supported on bearings located directly under the superstructure webs, and shims above the bearing were used to set the height after jacking. Vertical jacking was achieved by temporary jacks under the cradle either side of the slide bearings. See Figure 6.

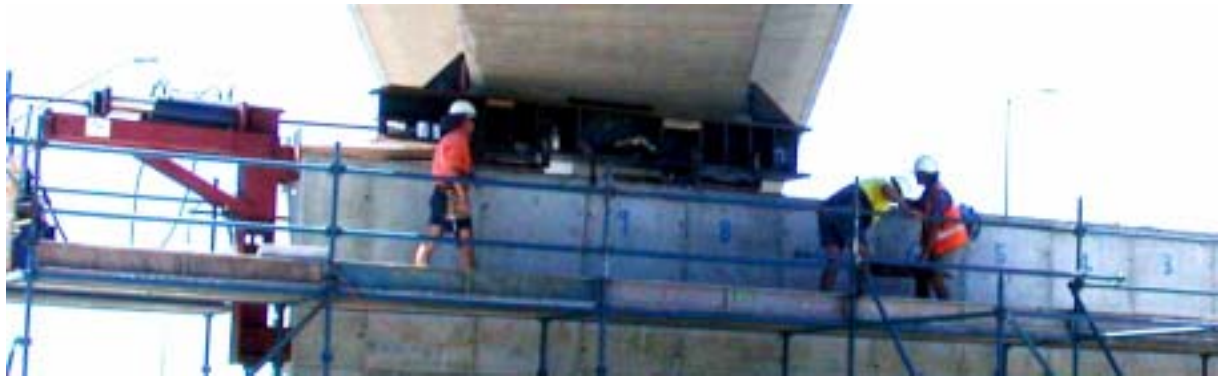
Figure 7: Support Cradle and Horizontal Jacking System at TS2

The horizontal movement was achieved by a hydraulic jacking system attached to a frame on the west end of the blade walls for TS2 and TS4 (with option to attach to TS1 and TS3 if required). The horizontal jack was attached to the bridge cradle via a 40mm diameter stress bar. In addition TS1 and TS4 had side guide rollers attached to the cradle to ensure horizontal movement only along the line of the blade wall. During the horizontal movement of the bridge, each cradle was moved along its blade wall on a series of launch pads placed under each bearing – the same as those used in incremental launching systems.

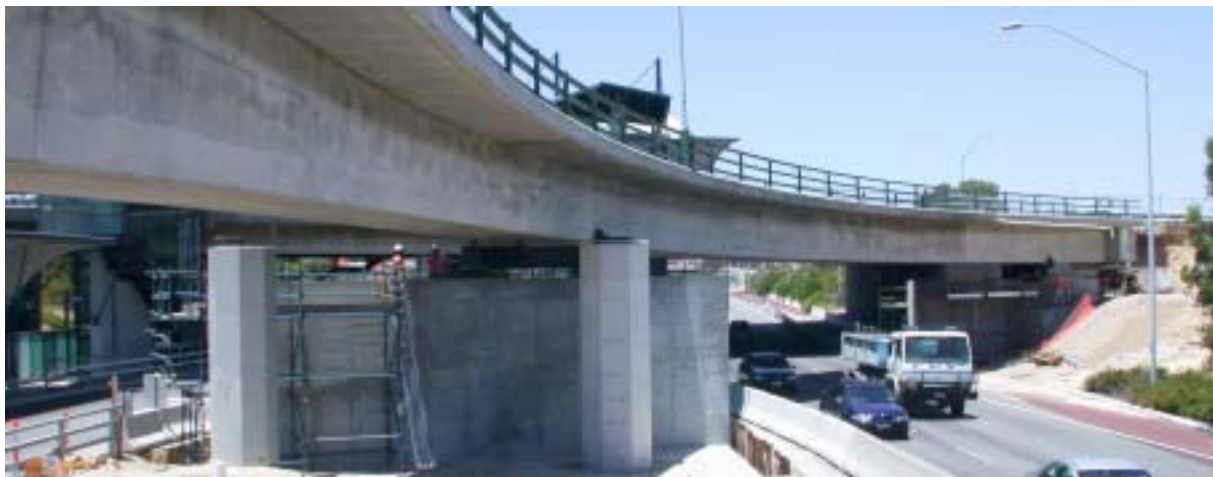
Figure 8: Bridge #1295 Nearly There!!!

Stage 2 - The horizontal move of the superstructure was carried out over a period of about 7 hours without incident. The freeway traffic flowed freely under the superstructure during the move.
